J. Franklin Thomas Farmstead
Adamstown vicinity
Private

Ca. 1845-1940

Maryland Historical Trust State Historic Sites Inventory Form

historic J. Franklin Thomas Farmstead

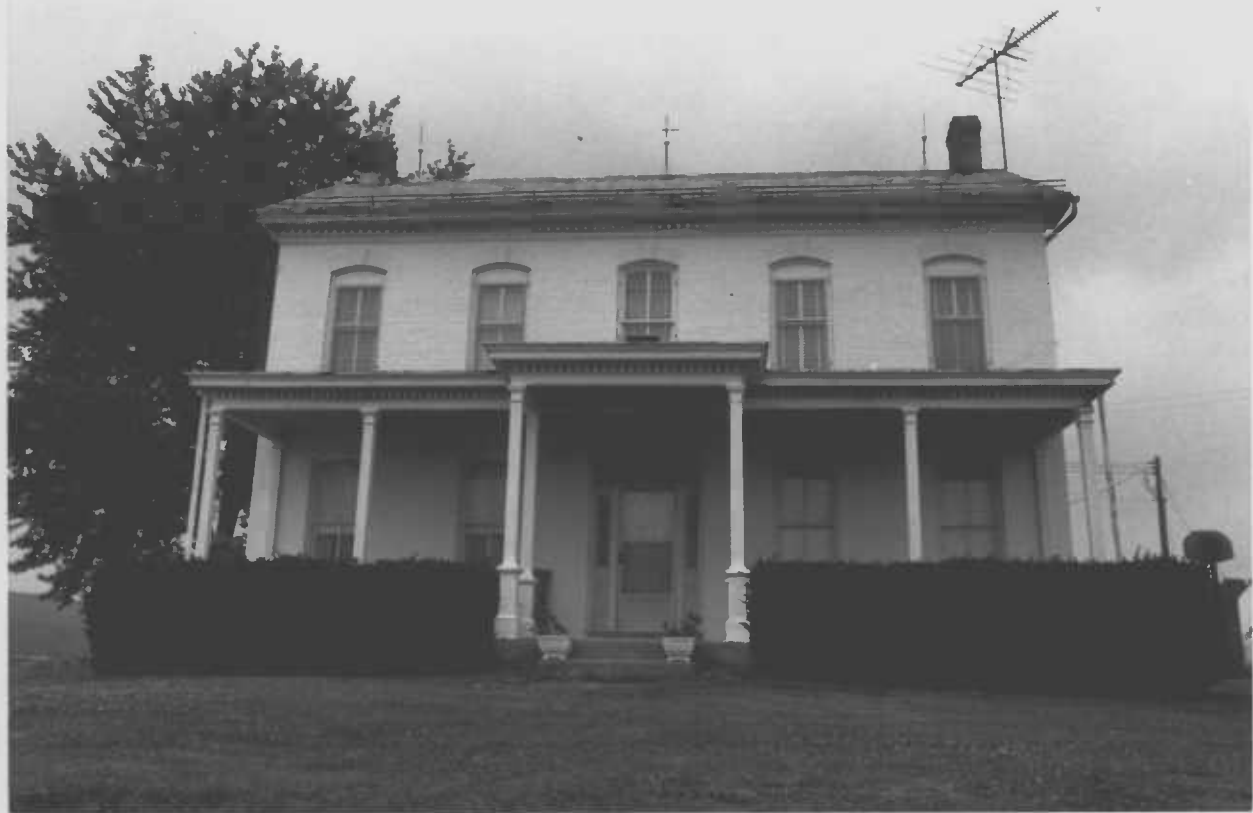
1/6

East elevation

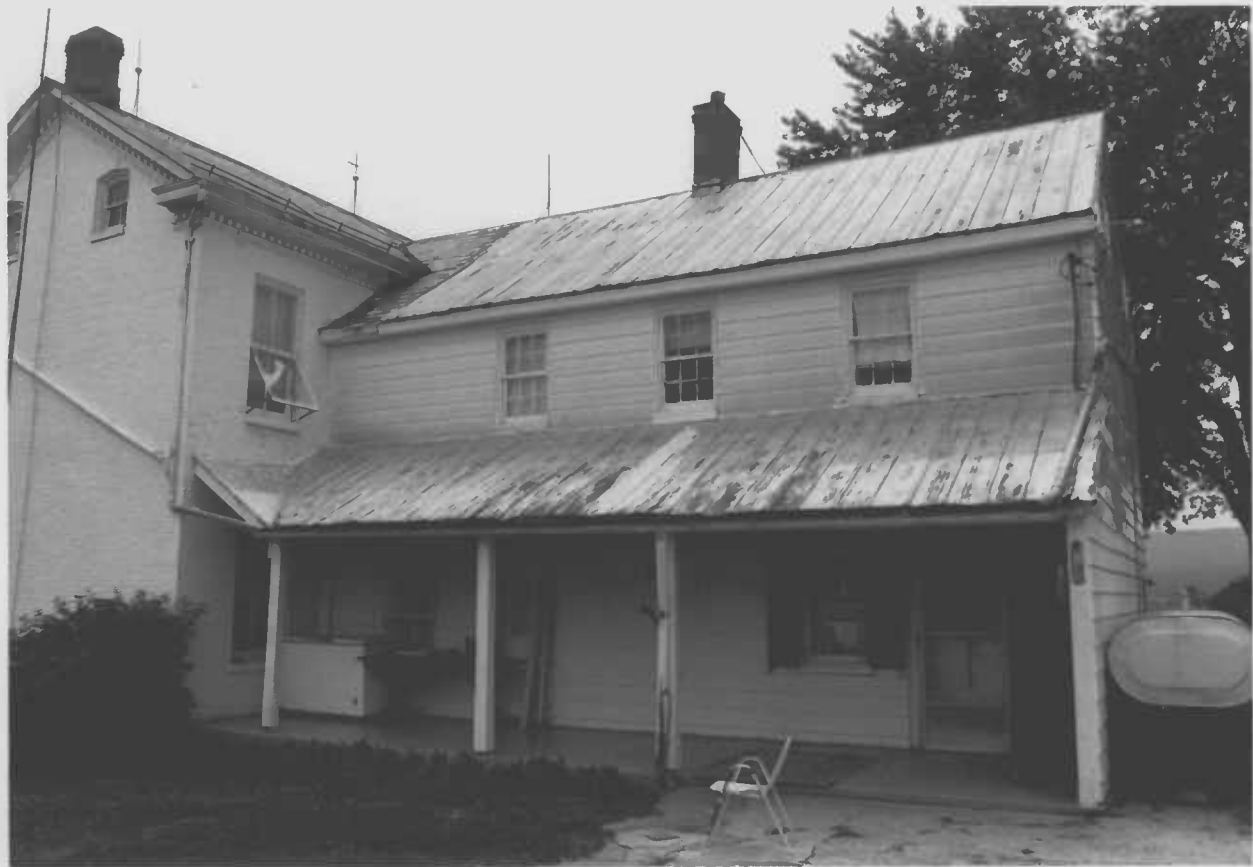
2/6

North elevation of bear wing

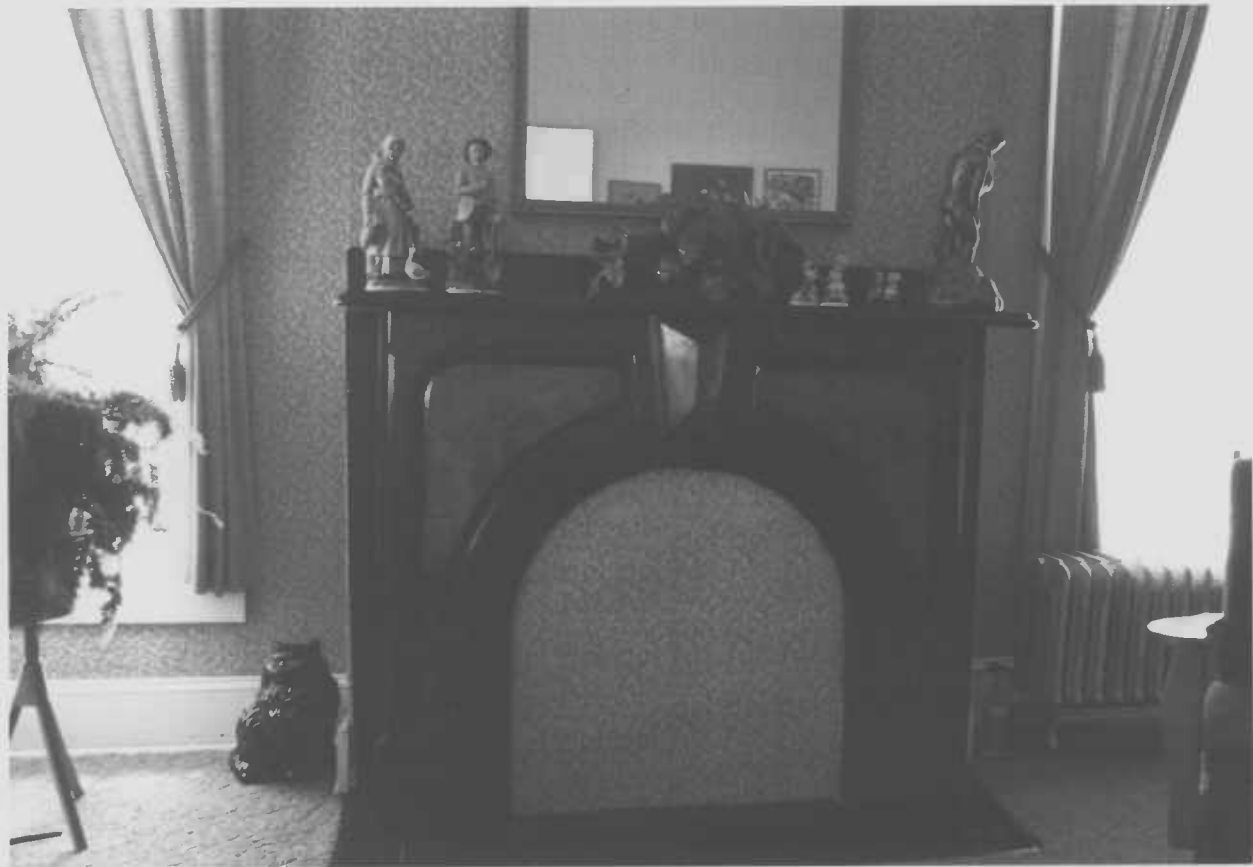
3/6

Mantel piece, west parlor

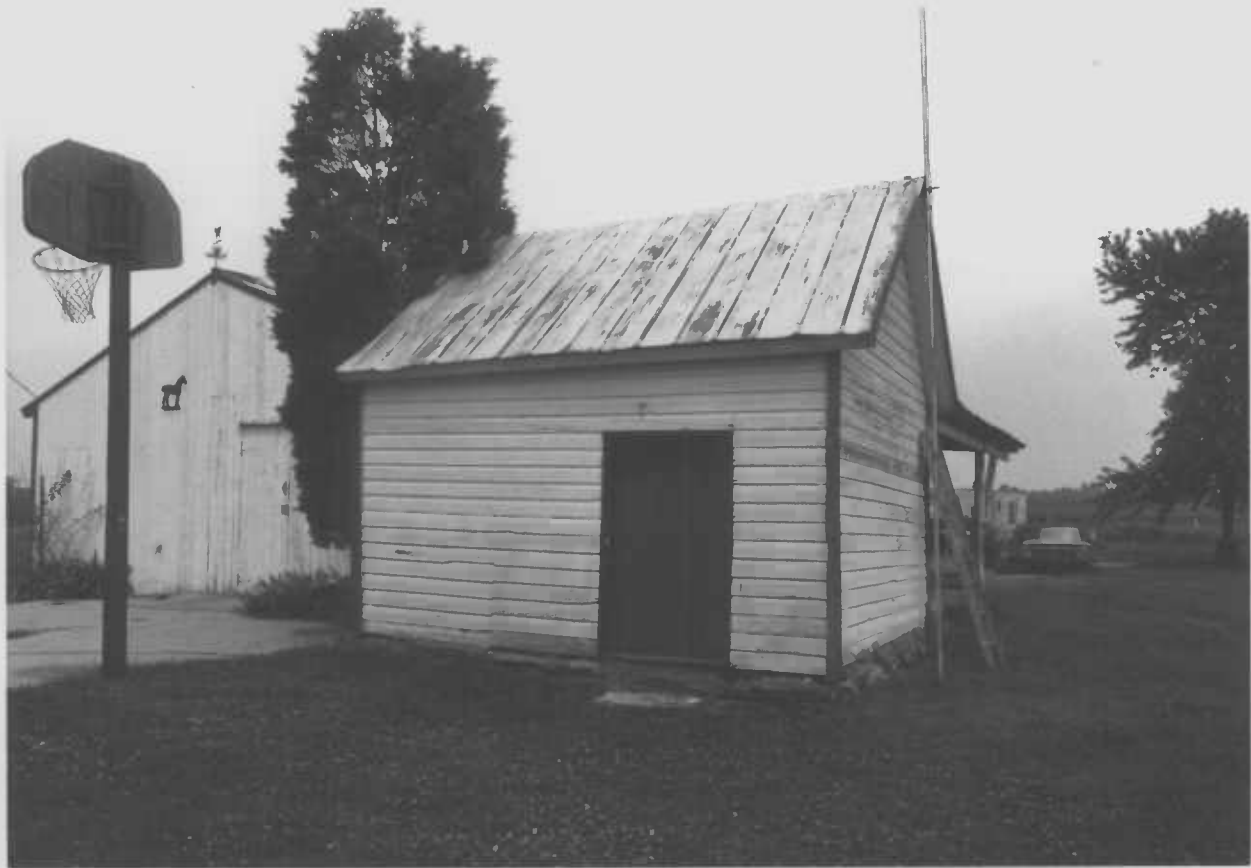
4/6

Smokehouse: The one-story log smokehouse is located north of the house and has german siding and a corrugated metal roof over the original shingles. A vertical board door is located in the south elevation. The gables on the east and west elevations are flush vertical boards. The smokehouse dates from at least about 1850 and may be as old as the log rear wing.

Smokehouse, southeast elevation

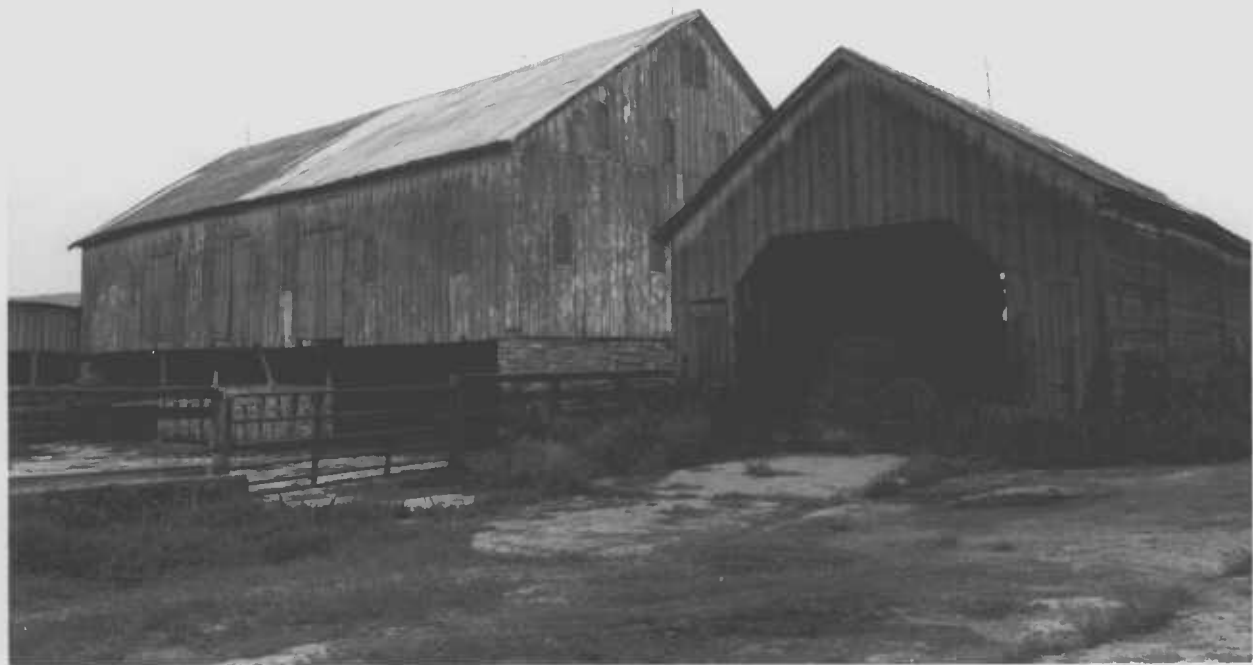
5/6

Wagon shed/corn crib: The frame wagon shed with corn cribs is located north of the garage. It appears to have been built during the period 1875 to 1900 and has vertical board siding and a corrugated metal roof. The drive passage is oriented to the south.

Bank barn: The frame bank barn was probably built about 1875-1880, according to the historical account in Williams & McKinsey's History of Frederick County (1910) on J. Franklin Thomas. It has board and batten and vertical siding with a corrugated metal roof over the original shingles. Louvred vents in arched openings are on all elevations.

Bank barn and wagon shed/corn crib,
east elevations

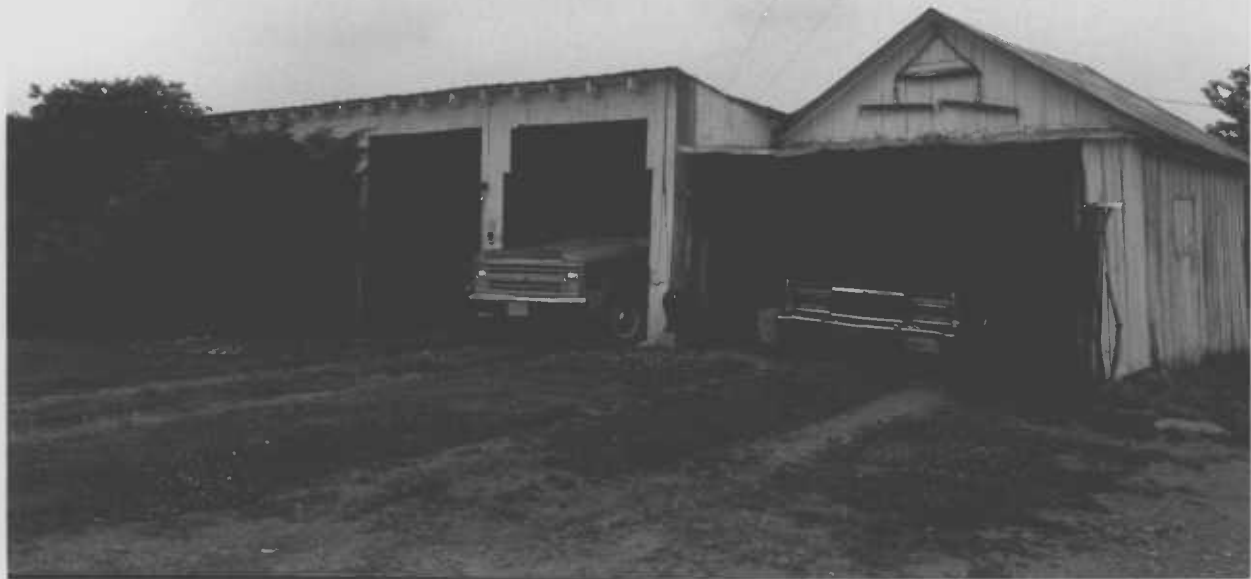
6/6

Chicken house/garage: The frame chicken house is located northwest of the dwelling. Possibly built about 1910-1920, the building is a rectangular structure.

with vertical board and german siding and a corrugated metal shed roof. According to Mr. Paul Biser, the current owner, the vertical siding was originally part of a wood stave silo that was demolished in the 1950's. When the chicken house was converted for use as a garage, an enlarged opening on the north end was made. A second garage section is an addition on the north end of the chicken house. It has board and batten siding and a gable corrugated metal roof.

Chicken house / garage, southeast elevation
